Smiths interconnect Customer claim n° : SHYF claim n° : C14924

PASCO Laurent / 09_11_2018 / Quality

D2 : Describe the problem : cracks on the insulator 57976-00 :

Problem Statement: Cracks on the female Insulators

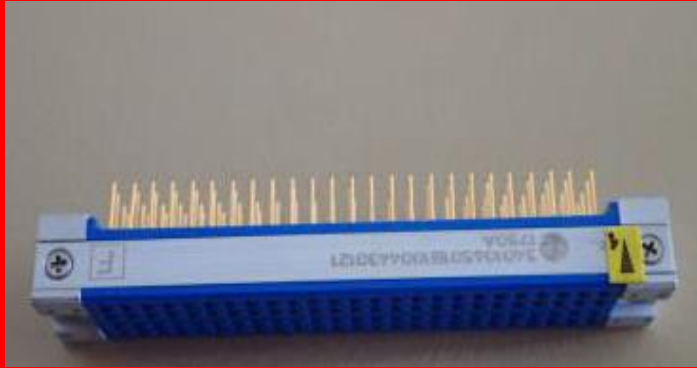
Global View :

- The cracks is always located at near the pin number one.
- Mainly seen on the side ;
- Some cracks can be also seen on the top of the insulator (on the same location).

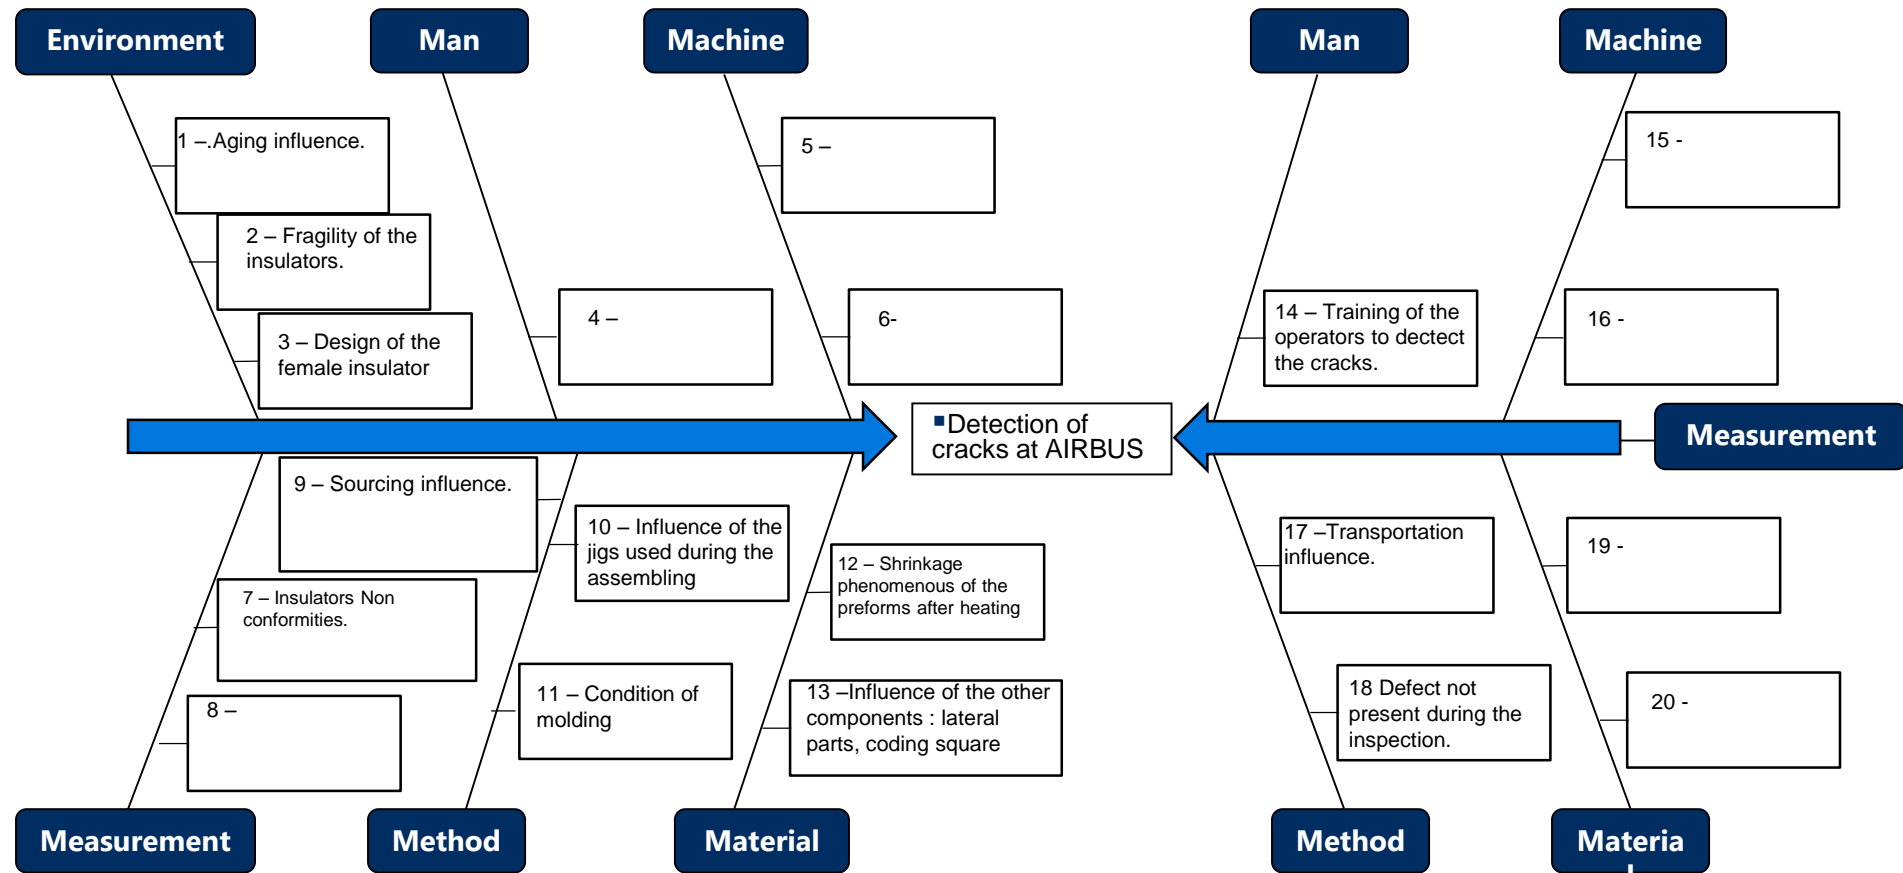
D4 : Root cause analysis / FishBone

N° from Ishikawa	Root Cause	Details	Reproducibility of the failure <i>Reproduction du défaut</i>		Document Ref	Who	Due date	Start date	End date	Major	Minor	Not retained
			Test	Results Remarks <i>Resultats – Rmq</i>	<i>Réf du document</i>	<i>Qui</i>	<i>Date prévue</i>	<i>Début de l'action</i>	<i>Fin de l'action</i>			
1-	Aging influence	Time & storage condition.	Aging test cycle to see if a crack could occur. No cracks detected after the VRT test.	The last claim was about 1- Insulator moulded in last Febuary and July. 2- Module in October.		L PASCO D LARCHEVE QUE	18-07-17		18-07-17			X
2-	Fragility of the insulators.	weakness at this area of the insulator.	1- Drop test on 10 pieces issued of the 2 lots stored. 2- Porosity inside the raw material ? 3- weakness at this area of the insulator.	1- Start of crack on 1 piece but on the top of the ending and not on the side. 2- No porosity detected on this side on the 4 pieces cut. 3- 99% of the cracks are sit on the blowholes side.		L PASCO S BAYEZ	15-03-18 14-03-18 08-03-18		15-03-18 14-03-18 08-03-18	X

3-	Design of the female insulator.	Design with a weakness on the Ending edges.	1-Comparison between the manufacturing process of a male and a female connector. 2- Comparison with a MDD female insulator.	1-No difference of manufacturing (molding, step of assembling...) between these 2 pieces. 2- No ending edges on the MHD male and on the MDD Female.	See « is / is not » page 5.	L PASCO	23-03-18		23-03-18	X		
7-	Insulators Non conformities.	Differents NC were found with the 2 supplying sources.	Check Ø of the holes and arrow effect.	No shrinkage was detected on the blowholes side and no arrow effect (insulators stored and pieces returned).		L PASCO S BAYEZ	22-03-18 17-04-18		22-03-18 17-04-18			X

Nr	CAUSES	ACTIONS	WHO QUI	DUE DATE DELAI	P	D	C	A
2	Fragility of the insulators : weakness on the blowhole side due to insufficient cleaning.	1- Confirm the implementation of the Working instruction at AMS : audit to be launched. 2- Implement the same Working instruction at the other supplier (MSI).	D GANDOSSO L PASCO L OUDJOUDI B STULL	1- 31/08/19 2- 31/08/19		X	X	
3	Design of the female insulator : comparison with the MHD male insulator and the MDD female insulator.	A design improvement was proposed = removal of the ending edge. This one was designed to retain the epoxy when it was a liquid process. It was kept after implementation of the preforms.	L PASCO JS LEFRILEUX S BOIVIN L OUDJOUDI	26/10/19		X		
11	T° of molding and time of curing	Our Supplier MSI carried out an Experimental plan with variation of the curing times and Temperatures. 1- Results : Best configuration were found at the lowest T° advised on the data sheet of the raw material. No possible action on the process. 2- Remaining actions : Safety stock before mold modification with 100% check at MSI : 10000 insulators.	L PASCO JS LEFRILEUX MSI	1- 18/06/19 2- 23/08/19		X
