INTERNAL VISUAL INSPECTION OF QUARTZ CRYSTAL UNITS

ESCC Basic Specification No. 2043501

Issue 3 February 2014

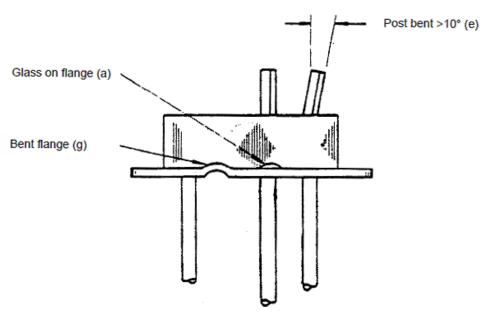
FIGURE 8 - HEADER DEFECTS

3.4 HEADER DEFECTS AND PRESENCE OF FOREIGN MATERIAL (SEE FIGURE 8)

- (a) Any glass on the flange or side of the header.
- (b) Any quartz element or part of a quartz element on the flange or side of the header.
- (c) Gold or nickel plating showing evidence of blistering or flaking.

- (d) Any solder preform on the flange which still resembles a preform.
- (e) Posts bent more than 10 degrees.
- (f) Any metal shavings on the flange or side of the header longer than the width of the flange.

- (g) Bent or deformed header flanges.
- (h) Any metallic particle on top of the header which is larger than 25 microns and not firmly attached to the header.

- (i) Any non-metallic particle larger than 25 microns in the major dimension on top of the header or on the insulating glass between post and header.
- (j) Gold overlapping the seals.

- (k) Cracked or chipped glass seals.
- (I) Non-uniformity of finish of lead or post, particularly at the glass seal.
- (m) Nicks or bulges in the lead diameter outside stated lead tolerances.

- (n) Bubbles or an area of adjacent bubbles in the seal area larger than 12.5% of the seal area.
- (o) Foreign particles enclosed in the glass seal.
- (p) The minimum distance between the lead and the body shall be 0.13mm.

- (q) Lead tilted by more than 5 degrees.

OFF-CENTRE LEADS (p)

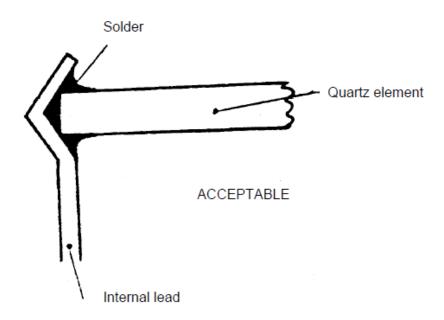
FIGURE 9 - INTERNAL LEAD TO QUARTZ ELEMENT JUNCTION

- (a) Crystal units with metal-plated quartz elements shall have intimate metal-to-metal continuity from lead to quartz element. Interference, friction, crimped or similar joining of parts, not reinforced by solder, welding, etc., shall not be acceptable (see Figure 9).
- (b) Eccentricity of quartz element with X_{min} less than $X_{max}/2$ (see Figure 10(a) and 10(b)).
- (c) Quartz element not aligned to within 10° of normal horizontal plane of the header.
- (d) Internal leads not within 10° of vertical and not uniform in length and construction.
- (e) Improper weld position of internal leads to post (see Figure 11):
 - A weld spot placed partially on internal lead.
 - B overlap between lower edge of internal lead and top of post less than 1 post diameter or 1mm, whichever is greater.

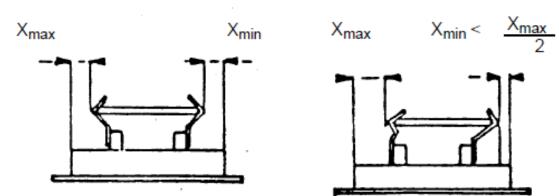
FIGURE 10 - ECCENTRICITY OF QUARTZ ELEMENT

(a) ACCEPTED

(b) REJECTED
