# **INTERNAL VISUAL INSPECTION OF ELECTROMECHANICAL SWITCHES**

**ESCC Basic Specification No. 2043701**

Issue 2	April 2003
---------	------------

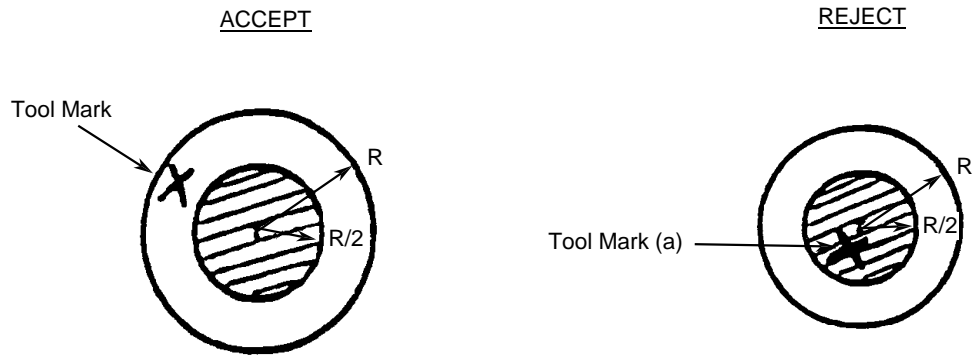
**4.1 FIGURE 1: TOOL MARKS**

Cause for rejection

(a) Tool marks on the active (shaded) area of the contact.

- (a) Tool marks on the active area of the contact (see Figure 1).
- (b) Scratches or visible damage.
- (c) Corrosion.
- (d) Loosening of contact rivet.

- (a) Tool marks on the active area of the contact (see Figure 1).
- (b) Scratches or visible damage.
- (c) Corrosion.
- (d) Loosening of contact rivet.
- (e) Contact position (see Figure 2).

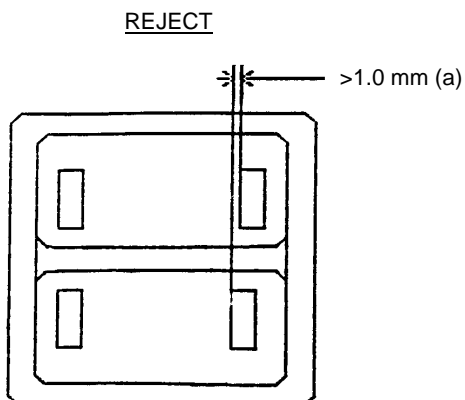
4.3 FIGURE 3: MISALIGNMENT OF HEADER ASSEMBLY

Cause for rejection

(a) Internal misalignment of terminals.

- (a) Internal misalignment of terminals greater than 1mm (see Figure 3).

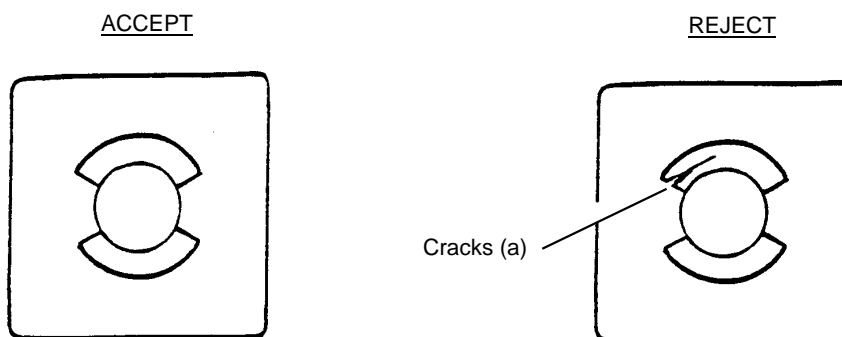
4.4 FIGURE 4: HOUSING: CRACKS IN CRIMPING OF BUSHING

Cause for rejection

(a) Cracks - it should be noted that tool marks are acceptable.

- (a) Uncleanliness of housing.
- (b) Dust or rust particles on inside surfaces.
- (c) Marks, burrs on edges.
- (d) Deformation by dents.
- (e) Incorrect position of mounting bushing.
- (f) Incorrect crimping of bushing (see Figure 4).
- (g) Incorrect assembly of insulator on lever (see Figure 5).

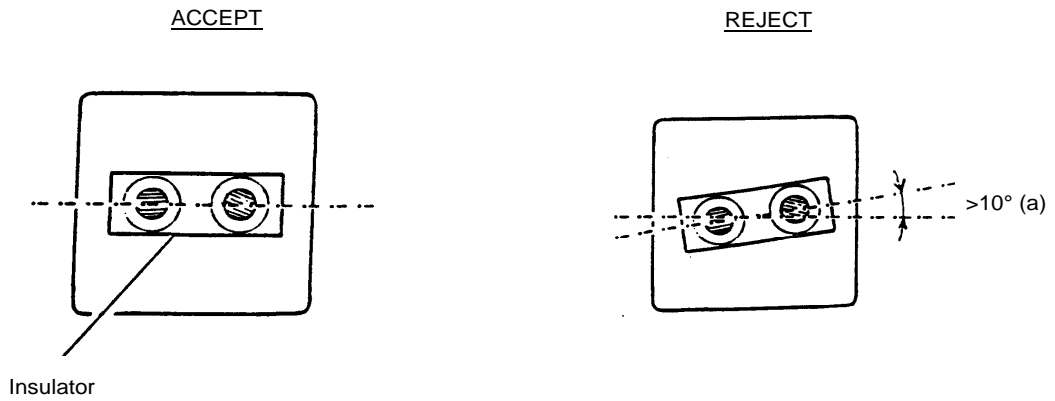
4.5 FIGURE 5: HOUSING: INSULATOR ON INTERNAL LEVER

Cause for rejection

- (a) Incorrect assembly of insulator on internal lever.

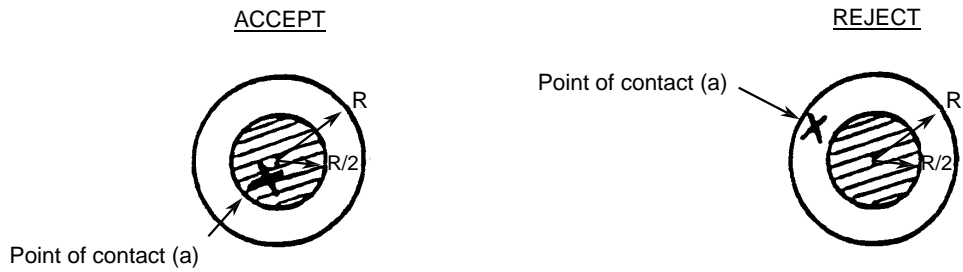
4.6 FIGURE 6: CONTACT ALIGNMENT

Cause for rejection

- (a) Point of contact out of the active area.

- (a) Incorrect contact alignment (see Figure 6).

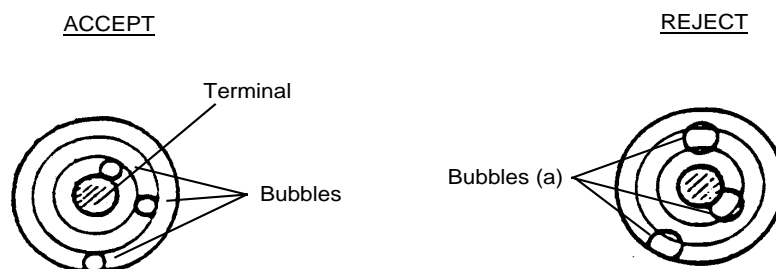
4.7 FIGURE 7: HEADER: BUBBLES

Cause for rejection

- (a) Bubbles or an area of adjacent bubbles in a glass seal whose area exceeds 12.5% of the seal area.

- (j) Bubbles or an area of adjacent bubbles in the seal area larger than 12.5% of the seal area (see Figure 7).
- (k) Foreign particles embedded in the glass seal.

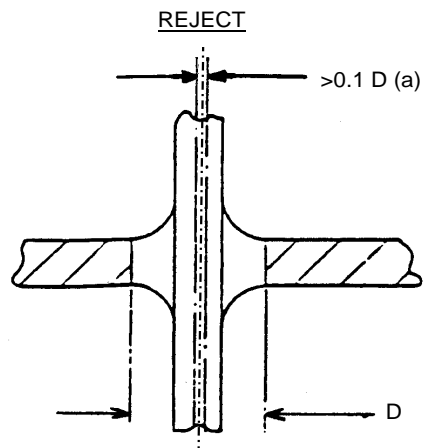
4.8 FIGURE 8: ECCENTRICITY

Cause for rejection

- (a) Eccentricity of terminal, passing through center of seal, greater than 10% of the seal diameter.

- (l) Eccentricity of lead passing through the centre of the glass-to-metal seal greater than 10% of the seal diameter (see Figure 8).
- (m) Terminal bent by more than 5°.

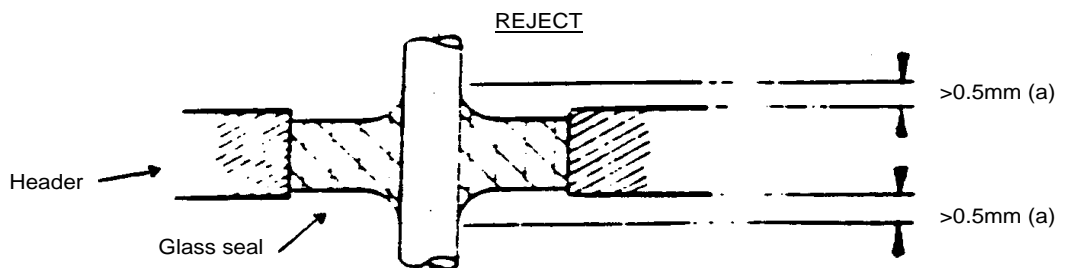
4.9 FIGURE 9: GLASS SEAL PROTUBERANCE

Cause for rejection

- (a) Non-conductive material on the terminal beyond a distance of 0.5mm from surface of the case.

- (n) Glass seal, or other non-conducting material, protruding above header along terminal by more than 0.5mm (see Figure 9).
- (o) Incorrect spring position (see Figure 10).

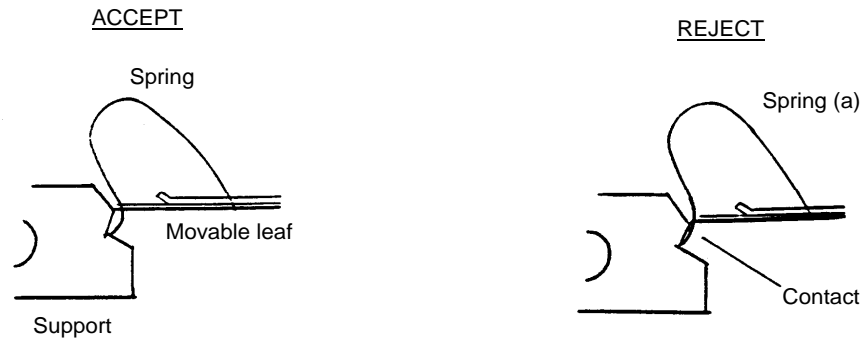
4.10 FIGURE 10: SPRING POSITION

Cause for rejection

- (a) Incorrect spring position.

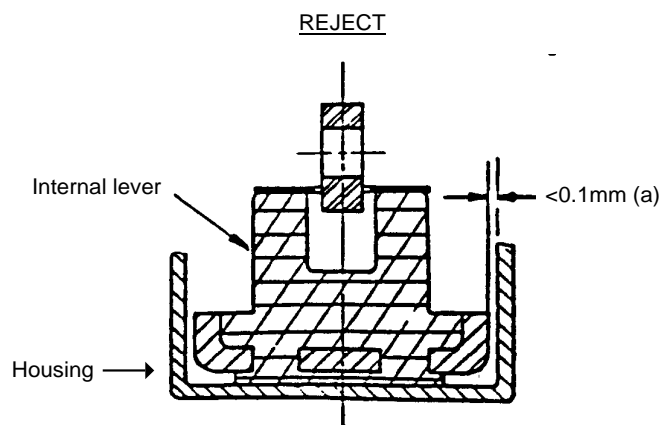
4.11 FIGURE 11: LEVER MISALIGNMENT IN SENSITIVE SWITCH HOUSINGS

Cause for rejection

- (a) Internal lever misalignment.

- (a) Uncleanliness of housing.
- (b) Dust or rust particles on inside surfaces.
- (c) Marks, burrs on edges.
- (d) Dents.
- (e) Deformation exceeding 0.2mm, except on membranes.
- (f) Any deformation by shock on the membranes.
- (g) Granular brazing alloy.
- (h) Internal lever misalignment, if applicable (see Figure 11).
- (i) Evidence of corrosion
