**INTERNAL VISUAL INSPECTION OF  
ELECTROMECHANICAL SWITCHES  
ESCC Basic Specification No. 2043701**

**ISSUE 1  
October 2002**

**INTERNAL VISUAL INSPECTION OF  
ELECTROMECHANICAL SWITCHES**

**ESA/SCC Basic Specification No. 2043701**

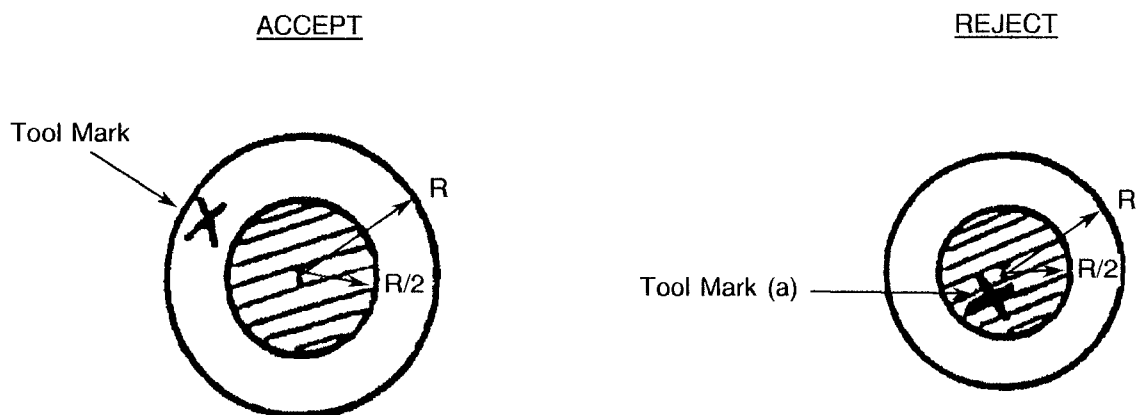
**FIGURE I - TOOL MARKS**

**Cause for rejection**

- (a) Tool marks on the active (shaded) area of the contact.

- (a) Tool marks on the active area of the contact (see Figure I).  
(b) Scratches or visible damage.  
(c) Corrosion.  
(d) Loosening of contact rivet.  
(e) Contact position (see Figure II).

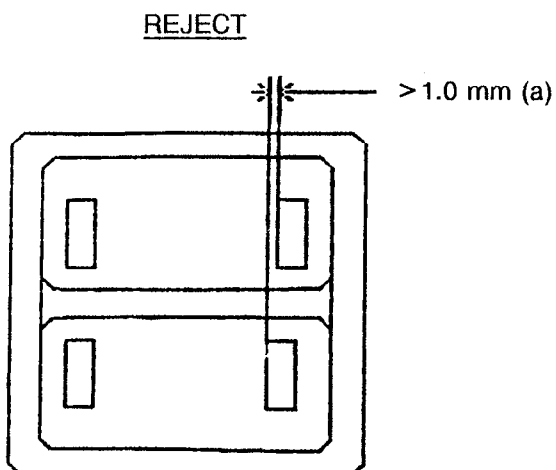
**FIGURE III - MISALIGNMENT OF HEADER ASSEMBLY**

**Cause for rejection**

(a) Internal misalignment of terminals.

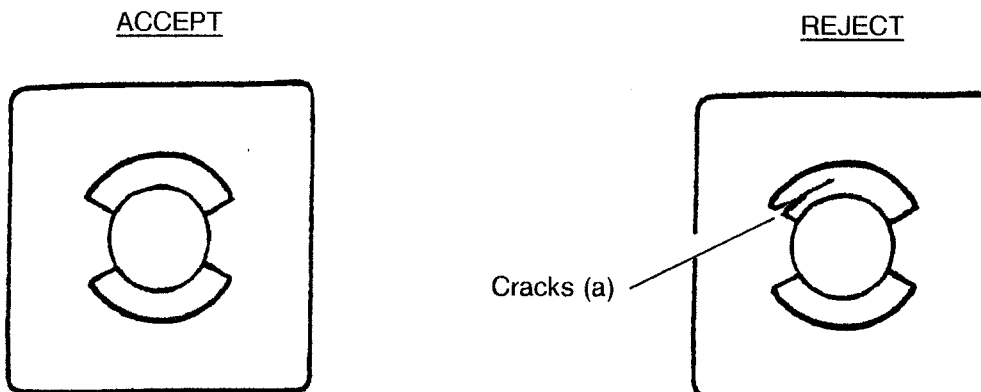
**FIGURE IV - HOUSING: CRACKS IN CRIMPING OF BUSHING**

**Cause for rejection**

(a) Cracks - it should be noted that tool marks are acceptable.

- (a) Uncleanliness of housing.
- (b) Dust or rust particles on inside surfaces.
- (c) Marks, burrs on edges.
- (d) Deformation by dents.
- (e) Incorrect position of mounting bushing.
- (f) Incorrect crimping of bushing (see Figure IV).
- (g) Incorrect assembly of insulator on lever (see Figure V).

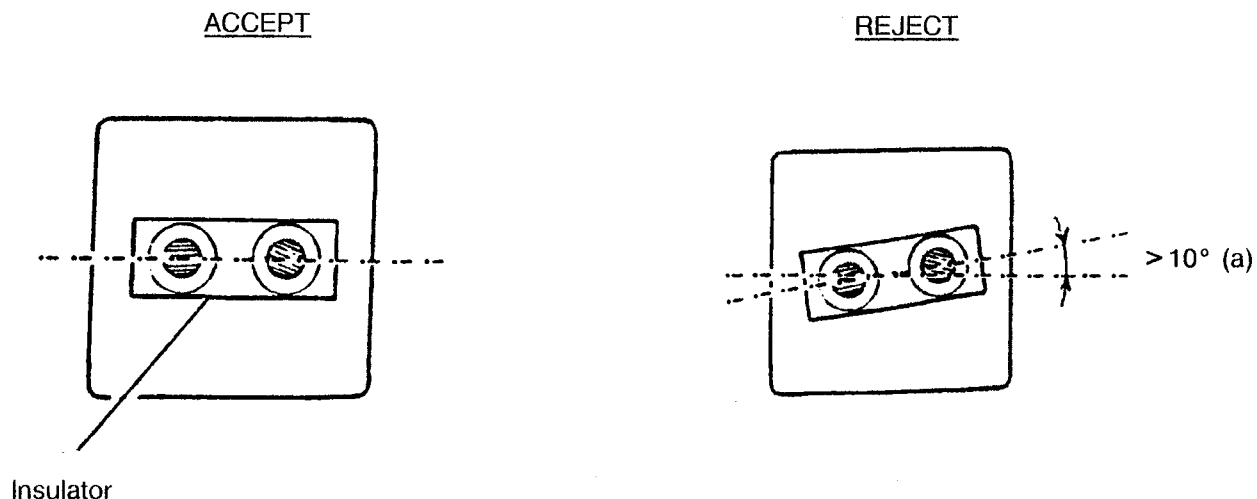
**FIGURE V - HOUSING: INSULATOR ON INTERNAL LEVER**

**Cause for rejection**

- (a) Incorrect assembly of insulator on internal lever.

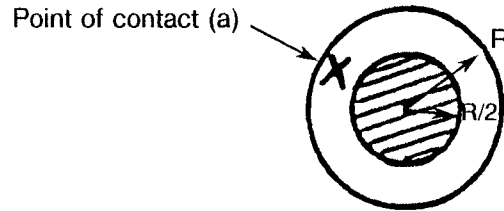
**FIGURE VI - CONTACT ALIGNMENT**

ACCEPT

Point of contact (a)

REJECT

**Cause for rejection**

(a) Point of contact out of the active area.

- (a) Incorrect contact alignment (see Figure VI).

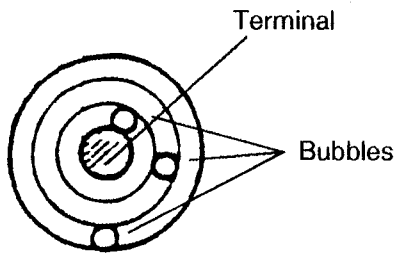
**FIGURE VII - HEADER: BUBBLES**

ACCEPT

REJECT

**Cause for rejection**

(a) Bubbles or an area of adjacent bubbles in a glass seal whose area exceeds 12.5% of the seal area.

- (j) Bubbles or an area of adjacent bubbles in the seal area larger than 12.5% of the seal area (see Figure VII).
- (k) Foreign particles embedded in the glass seal.

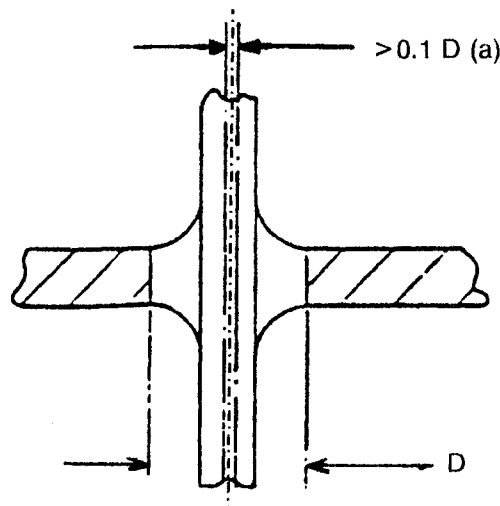
**FIGURE VIII - ECCENTRICITY**

REJECT

**Cause for rejection**

(a) Eccentricity of terminal, passing through center of seal, greater than 10% of the seal diameter.

- (l) Eccentricity of lead passing through the centre of the glass-to-metal seal greater than 10% of the seal diameter (see Figure VIII).
- (m) Terminal bent by more than 5°.

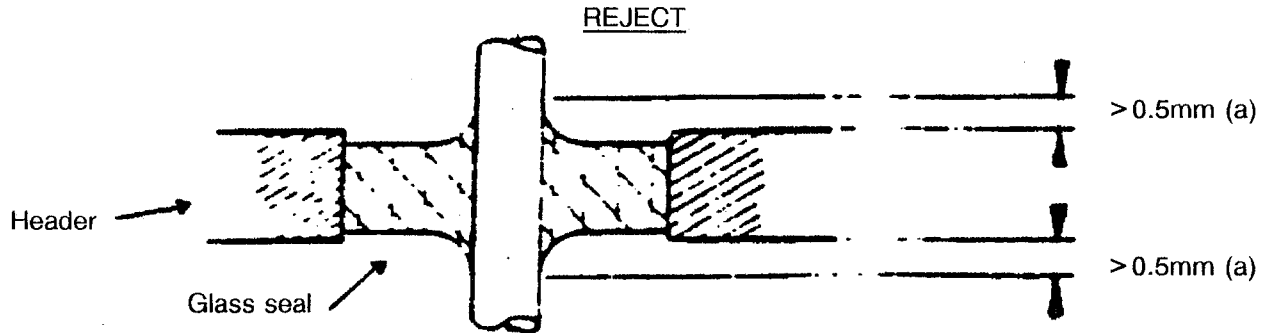
**FIGURE IX - GLASS SEAL PROTUBERANCE**

**Cause for rejection**

- (a) Non-conductive material on the terminal beyond a distance of 0.5mm from surface of the case.

- (n) Glass seal, or other non-conducting material, protruding above header along terminal by more than 0.5mm (see Figure IX).
- (o) Incorrect spring position (see Figure X).

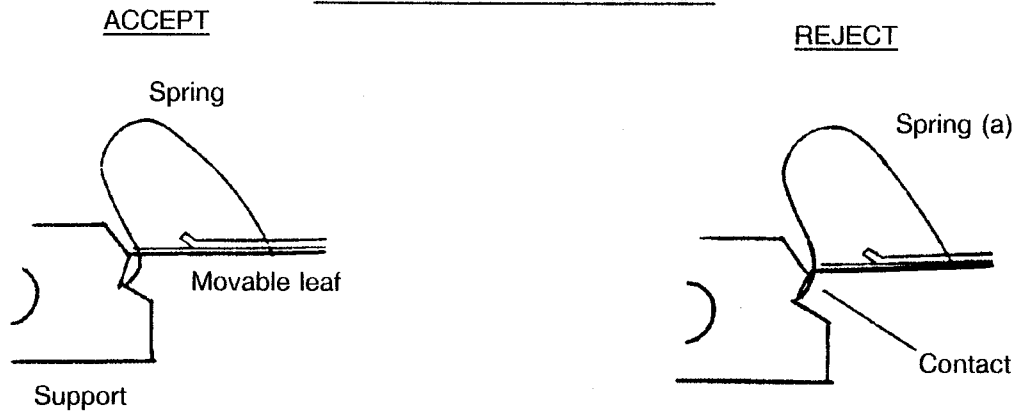
**FIGURE X - SPRING POSITION**

**Cause for rejection**

- (a) Incorrect spring position.

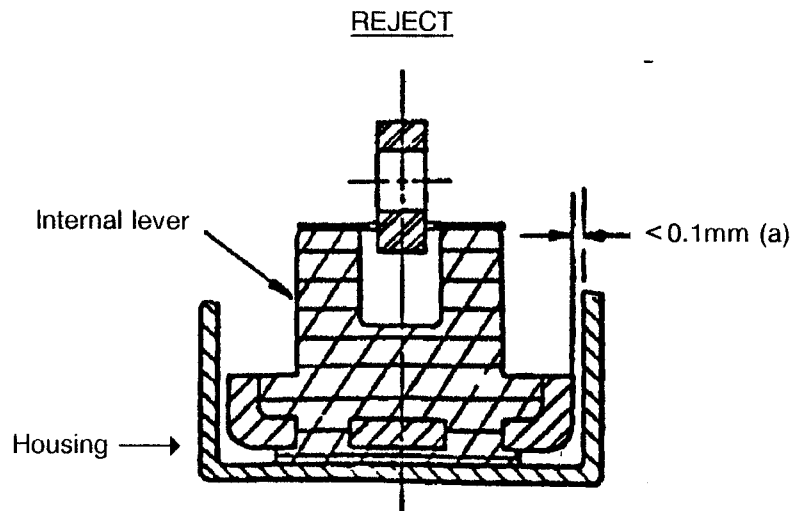
**FIGURE XI - LEVER MISALIGNMENT IN SENSITIVE SWITCH HOUSINGS**

**Cause for rejection**

- (a) Internal lever misalignment.

- (a) Uncleanliness of housing.
- (b) Dust or rust particles on inside surfaces.
- (c) Marks, burrs on edges.
- (d) Dents.
- (e) Deformation exceeding 0.2mm, except on membranes.
- (f) Any deformation by shock on the membranes.
- (g) Granular brazing alloy.
- (h) Internal lever misalignment, if applicable (see Figure XI).
- (i) Evidence of corrosion
